How The Towers Fell – Part 3/3
A Plausible Explanation for How the Twin Towers and Seven WTC Collapsed

Joe Englot, PE
 HNTB Corporation

Structural Engineering Webinar Series
 Tuesday, February 1, 2022
 1:00 PM (Central time)

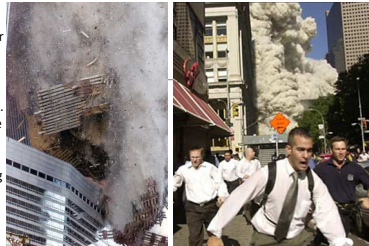
Above left: At 9:59 AM lower part of Tower 2 is seen collapsing on top of the Marriott Hotel where my co-workers had gathered to start the emergency recovery work. Fortunately, they survived the incident. Above right: Huge debris cloud from the collapse of Tower 1 at 10:28 AM is seen behind people who were evacuating away from the site the WTC site.

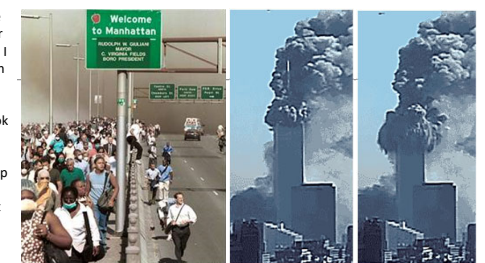
Above left: The City of NY stopped all mass transit systems and closed all tunnels and bridges to and from Manhattan to vehicular traffic. People are seen trying to get home by walking. Above right: A view of Tower 1 collapsing at 10:46 AM which I watched from the subway train I was on as it crossed the Williamsburg Bridge taking me from Manhattan to Brooklyn. the train stopped at the first station and went out of service.

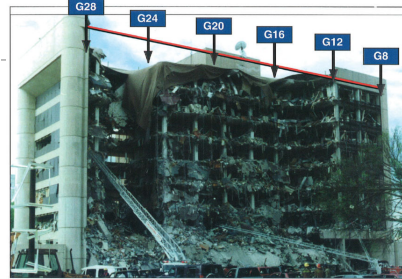
Figure 1-14 Damage to north and east sides of Murrah Building.

Example of Vertical and Lateral Progressive Collapse: 1995 Oklahoma City Bombing Progressive Collapse (Reinforced Concrete Structure)

Look at the attack of the Alfred P. Murrah federal Building attack and collapse (Oklahoma City Bombing).

- April 19, 1995 case of domestic terrorism.
- Ryder Box Truck loaded with 4,000 lb. of ANFO (Ammonium Nitrate and Fuel Oil). Also referred to as a fertilizer bomb.
- Did the bomber benefit from the knowledge that the 1993 WTC Bomber used 1,000 Lb. plus of explosives and failed to achieve a collapse? Maybe.
- The charge placed near one of the exterior tower columns led to a progressive collapse that destroyed 1/3 of the building and killed 168 people including 19 children.

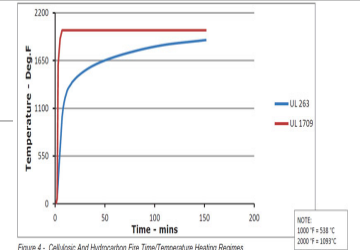
UL 263 - "Fire Tests of Building Construction Materials," and ASTM E119 - "Standard Test Methods for Fire Tests of Building Construction and Materials," were developed to simulate building fires, often referred to as 'cellulosic fires.' This heating regime was developed to simulate the type of fires that occur in commercial buildings with a simulated exposure based on a post flashover room fires utilizing wood, cotton and paper-based combustibles.

At 5 minutes into the fire test, the temperature within the furnace reaches 1,000°F. The temperature gradually increases during the test and, at 4-hours, the temperature within the furnace reaches 2000°F. This is considered to be the 'standard' time/temperature heating regime for buildings.

However, for installations which include oil, gas and petrochemicals fuels, an alternative 'Hydrocarbon' time/temperature regime may be more appropriate. The test method designed to simulate fires using hydrocarbon fuels employing greater energy input is ANSI/UL 1709 - "Standard for Rapid Rise Fire Tests of Protection Materials for Structural Steel".

Figure 4 - Cellulosic And Hydrocarbon Fire Time/Temperature Heating Regimes

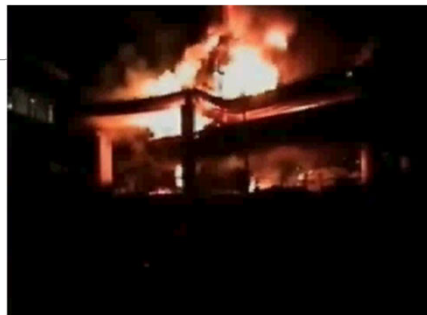
Oakland, CA Highway I 80 Interchange Bridges Collapse From Fuel Tanker Truck Fire

- 3:41am - Tanker overturns
- 3:55am - Oakland FD arrives at scene
14 minutes
- 4:02am - I-580 overpass collapses
21 minutes
- Approx. 5:30am - fire under control
