Materials and structures

The collapse of the World-Trade Center towers, on September 11, 2001, has raised questions about the design principles in high-rise buildings. In this article, we first consider the likely failure mechanisms that may have ultimately led to the collapse of the Twin towers. This analysis is based on a materials-to-structures approach, in which we look both at the characteristic behavior of the construction materials and the design details of the buildings. The very fact that the buildings survived the crash of the planes into the buildings suggests that a time dependent behavior at the material level affected the structural stability of the structure to the point of failure. On the other hand, the failure per se reveals the existence of a weakest link in the structural system, which ultimately failed because of a lack of redundancy. We then turn to the question whether —from an engineering point of view— skyscrapers will continue to have a future in the 21st century despite the increased vulnerability of our mega-cities. New materials-to-structures engineering solutions are also discussed, which in time could provide a new technology of redundancy to amelior

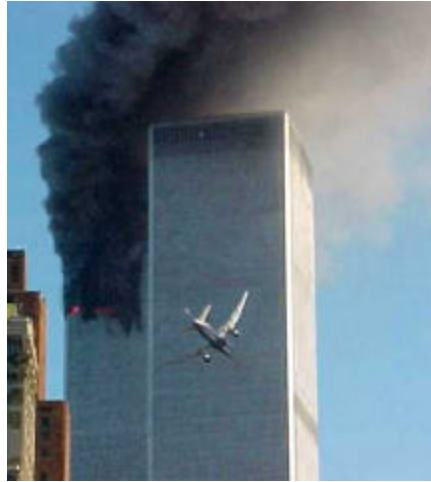
Figure 2: Boeing 767 aircraft approaching the South Tower (www)

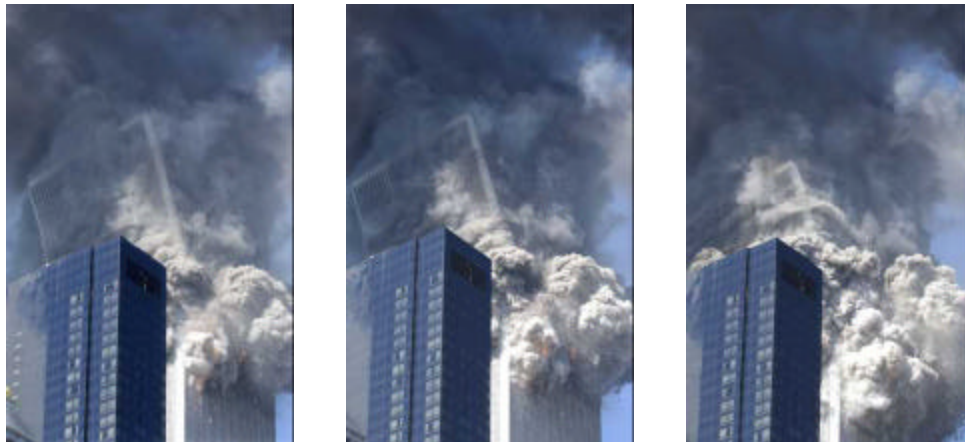
Figure 3: Progressive collapse of the South Tower (Photos from AP)

The South Tower collapsed suddenly at 9:59am, 56 minutes after the impact. Tilting occurred in the upper portion (Figure 3), which was immediately followed by a total collapse top down in about 10-12 seconds. The North Tower collapsed at 10:28am in a very similar fashion, 102 minutes after the impact. Figure 4 shows the collapsed building with the perimeter

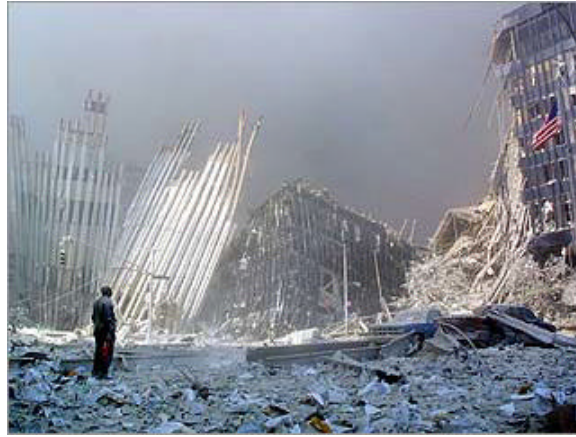
Figure 4: Collapsed tower with perimeter columns still linked at the bottom floors (www)

steel columns several stories high still linked together at the lower levels. In the collapse of the two WTC towers, a three-step failure mechanism may have been involved at different scales:

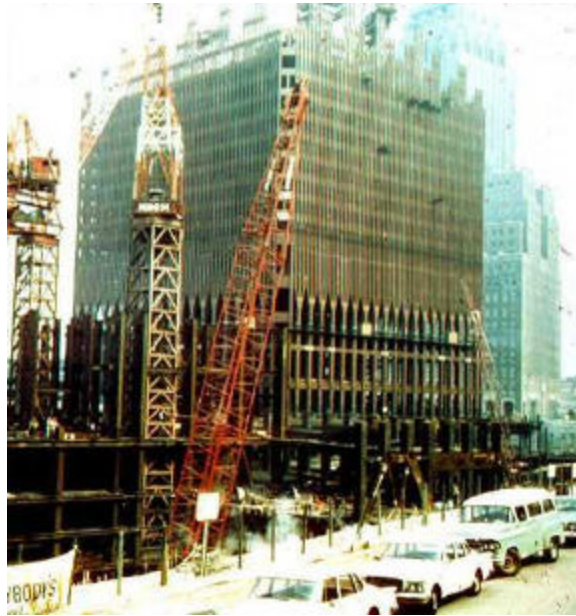
Figure 6: Towers under construction (www)

The complex was designed by Minoru Yamasaki and Associates of Troy, Michigan, and Emerith Roth and Sons of New York. The structural engineers were John Skilling and Leslie Robertson of Wortington, Skilling, Helle, and Jackson. The site excavation had begun in 1966 and construction of the towers started two years later. The first tower (WTC-1) was completed in 1970 and the second tower (WTC-2) was completed in 1972. Figure 6 shows one of the towers under construction.

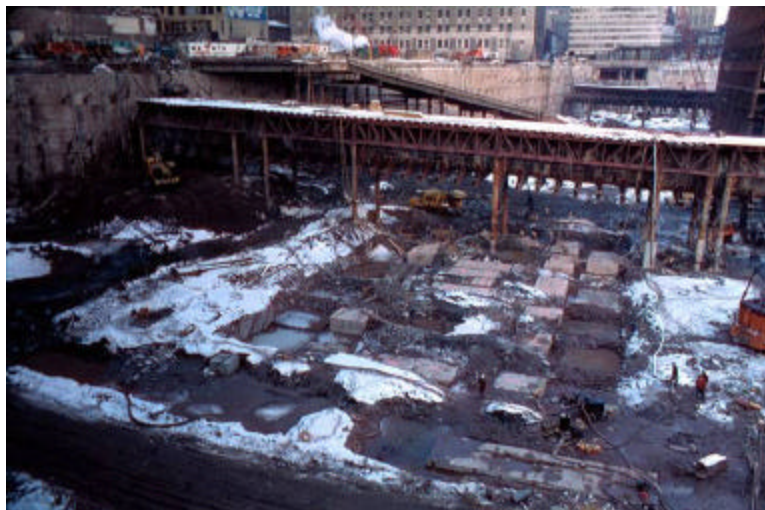
Figure 7: View of the bathtub (www)

The WTC buildings were supported by gigantic foundations. They rested on bedrock 21m (70ft) below ground. In the area that contained the twin towers, more than a million cubic yards of earth and rock were removed to place a basement that was 299m \times 155m \times 21m (980ft \times 510ft \times 70ft). The basement housed a commuter rail station, a 2000 car parking area, mechanical equipment rooms, and storage. Prior to excavation, underground walls were built all the way down and into the bedrock to withstand the external water and earth pressure, and

to prevent the undermining of adjacent buildings and streets. These walls were 7 story high, heavily reinforced concrete walls. The completion of the walls around the entire eight-block area resulted in a cutoff boundary around the site to be excavated. The excavated area, which is generally referred to as the “bathtub”, is shown in Figure 7.

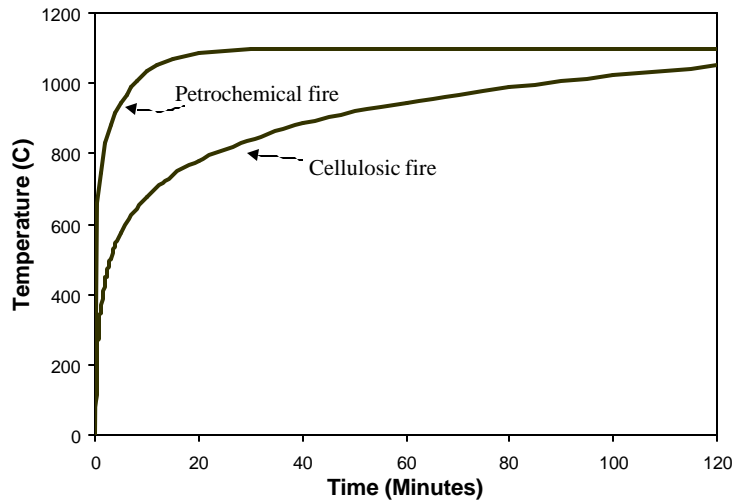
Figure 12: Fire curves (ISO, 1975)

Generally, unprotected steel in a high temperature environment does not perform well as a structural material due to the fact that steel has a high thermal conductivity and the members made of steel usually have thin cross sections. Typical fire proofing materials for steel structures are sprays (mineral fiber, vermiculite plaster), boards (fiber-silicate or fiber-calcium-silicate, gypsum plaster), and compressed fiber boards, (mineral wool, fiber-silicate). Typical thicknesses of insulating materials generally vary from 15mm to 50mm. Figure 17 shows two standard fire curves corresponding to combustible cellulosic material and a material of petrochemical origin. Steel temperatures for a structural beam for unprotected and protected steel together with a standard fire temperature is shown in Figure 18 (ISO, 1975; Buchanan, 2001).

Standard fire curves, shown in Figure 17, do not consider the initial explosion at impact. However, they can be considered as a first approximation to the rapid temperature rise to which the structural members in the towers could have been subjected after the impact. Given the rapid burning of the jet fuel, a temperature of 600°C-700°C (corresponding to about one half of the steel melting temperature) could have been reached essentially in a matter of minutes. Any structural steel member without or insufficient fireproofing (destroyed e.g. by the impact, and thus directly exposed to the high temperature) would have undergone substantial thermal damage and thermal softening. On the other hand, the fireproofing increases the thermal inertia of the member by delaying the heat diffusion into the material. It is likely that this heat diffusion, slowed down by fireproofing, was one of the rate determining mechanisms that delayed the collapse initiation in time. In fact, it can be shown, from dimensional analysis, that the critical time span t during which a steel member of thickness H with a fireproofing at its surface of thickness e , is protected by fireproofing (see Figure 20) is scaled by:

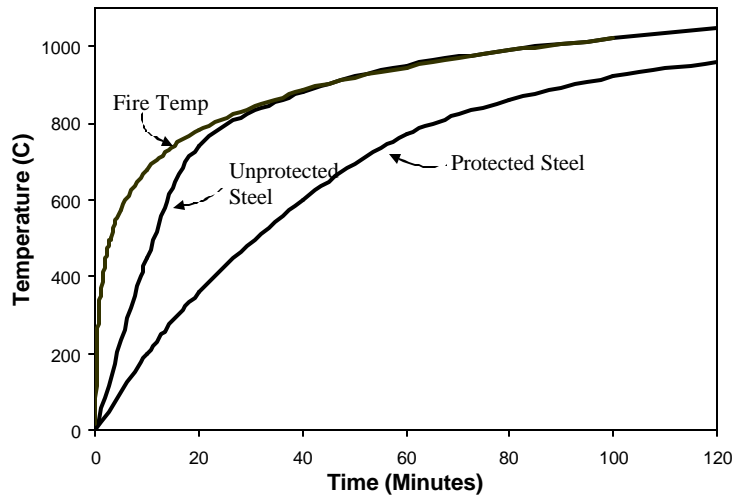
Figure 13: Temperatures for protected and unprotected beams exposed to fire (Buchanan, 2001)

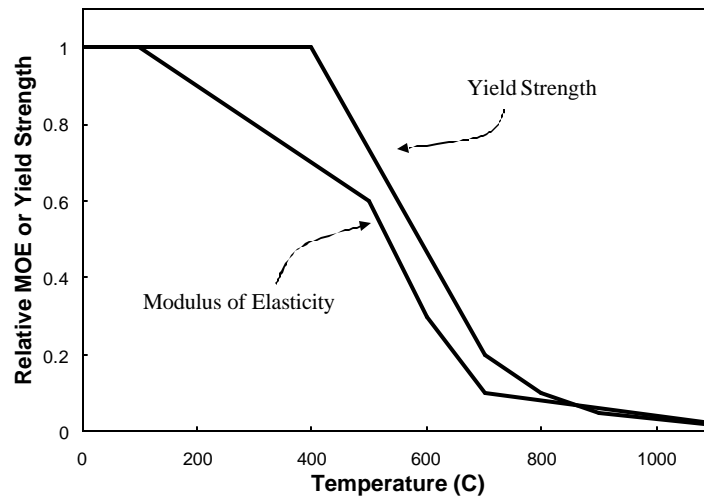
Figure 14: Reduction in yield strength and modulus of elasticity of steel as a function of temperature (EC3, 1995)

and thermal damage, respectively. By loss of stiffness (thermal damage), we mean an increase of the deformability of the material under load. A part of this increased deformability is known as thermal creep, and results from the higher agitation of the atoms of steel at high temperatures, which increases the susceptibility to and likelihood of deformation. Figure 19

shows the relative strength and stiffness degradation upon increasing temperature. At a temperature level of about 600°C-700°C, which corresponds roughly to one half of the melting temperature of steel, strength and stiffness of steel are reduced to 50% and 30%, respectively, of the initial value. Still, we should note that the temperature dependence of strength and stiffness of steel is a material property, which only affects the structural response if the member is heated. This involves at least two further physical processes: heating rate and heat diffusion.

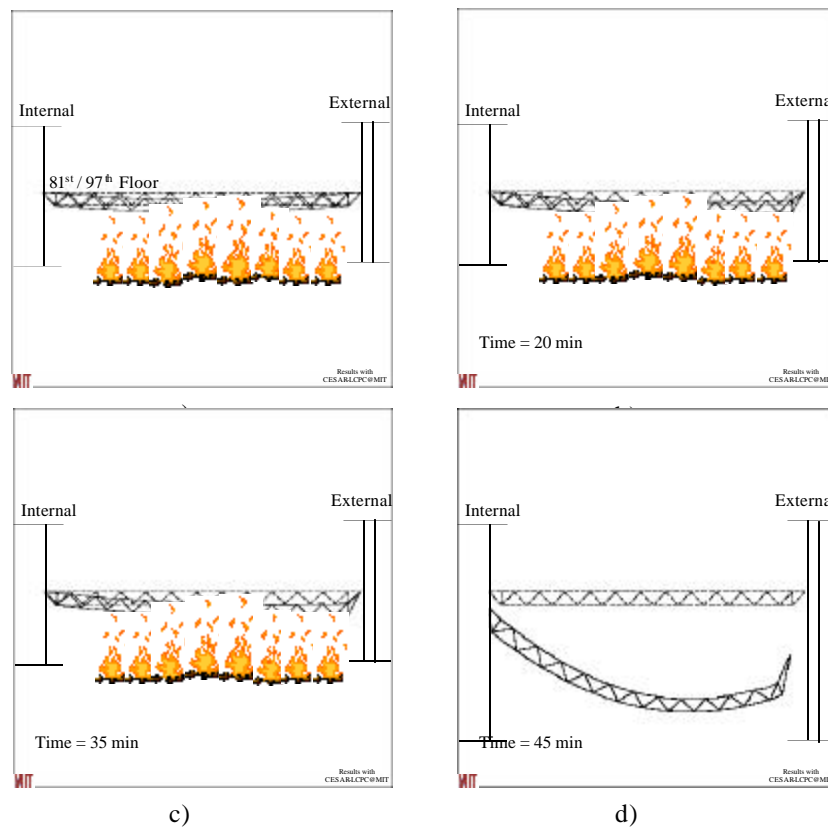
Figure 16: Finite element simulation of the floor collapse from end joints

Figure 21 (a), (b), (c), and (d) displays the results of finite element simulations of the slab truss system subjected to non-uniform heating. This non-uniform heating may have resulted from locally damaged or insufficient fireproofing and the higher thermal damage of the high-strength bolt connections with the outer façade. In the numerical study, the non-uniform heating effect is taken into account by a 100 times higher thermal exchange coefficient (see eq. (1)) of the end diagonal truss at the external façade, thus considerably reducing the fire protection time. As the results show, this weak point in the fireproofing

system could actually be the weakest link of the entire system: while uniform heating would have led to a uniform bending and yielding (see Figure 21 (a)), an increased local thermal damage of one structural element leads to a rigid body motion of the statically determinate truss system (see Figure 21(c)), which ultimately causes failure of the truss system. This weakest link situated at the end supports, to which the steel truss system was mounted by bolts, may explain the failure of the truss system in a shorter time span than the nominal fireproofing time. This finding based on model-based simulation is consistent with forensic studies carried out on the WTC-site after Sept 11, which showed that several of the end supports were either strongly deformed (indicating exposure to very high temperatures), or perforated by the bolts.

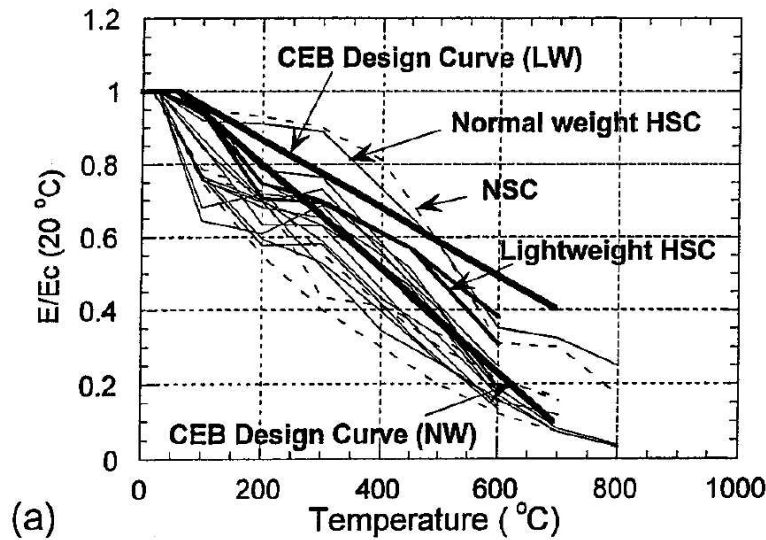
Figure 17: Thermal damage of concrete: loss of stiffness at high temperature (from the compilation of data by Phan, 1997)

inclusion, thermal instability of some mineral components of hydrated cement at some 400°C, transformation of aggregates at some 800°C, and so on. The thermal softening of concrete results in addition from a dehydration of concrete, leading to a loss of strength of the material. Typical curves of thermal damage and thermal softening for steel are shown in Figure 19 and thermal damage and thermal softening of concrete are shown in Figure 22 and Figure 23,

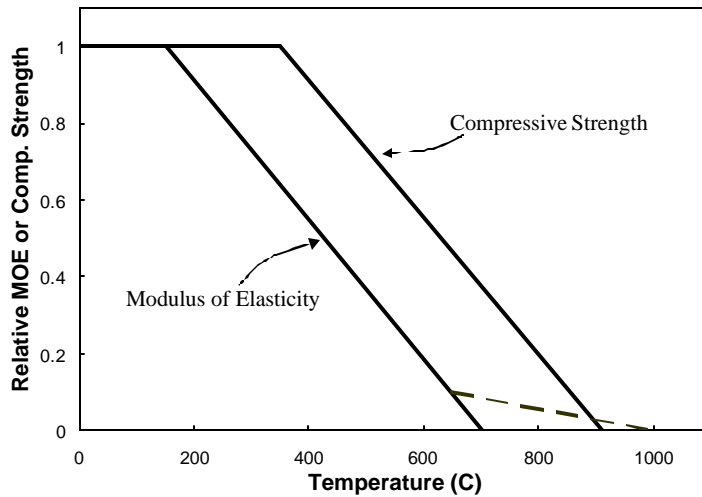
Figure 18: Idealized curves for thermal damage and thermal softening of concrete at high temperature (BSI, 1985)

respectively. Figure 24 shows the combination of these two effects as design curves. A comparison of these four figures shows that there is indeed little difference between concrete and steel on a material level.
